Failure Analysis of OH-58 Kiowa Warrior Drive Gear Shafts

ARL-TR-3827

June 2006

The objective of this report is root cause determination for the 15-hp spare drive gear failure.

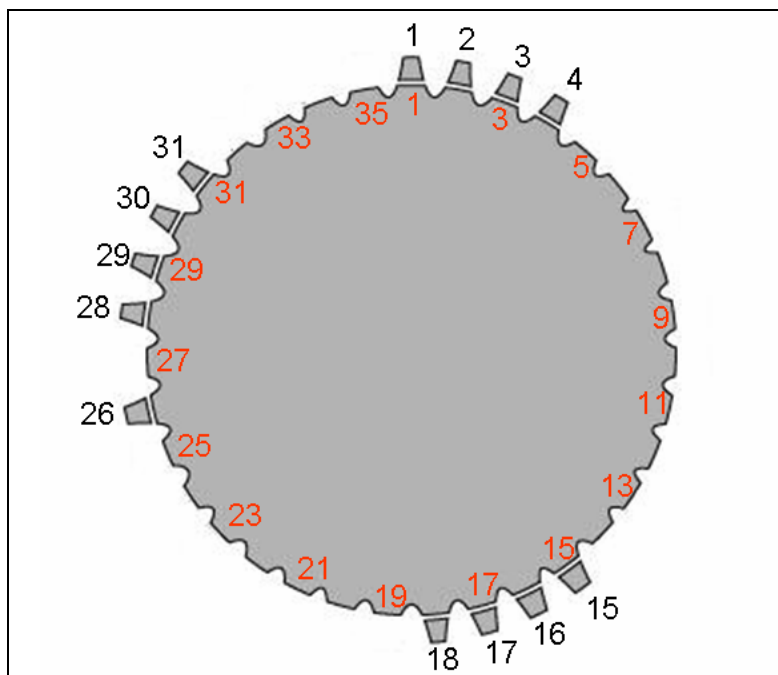
All teeth were stripped or separated from the failed gear; many fracture surfaces were too marred to yield useful information. Thirteen teeth were recovered essentially intact. The recovered teeth were successfully matched to their corresponding location on the gear by examination of the tooth geometry and fracture topography. The location of each tooth relative to the others is shown in figure 1.

Figure 1. Location of recovered teeth on spare drive gear. (Gear is driven counterclockwise.)

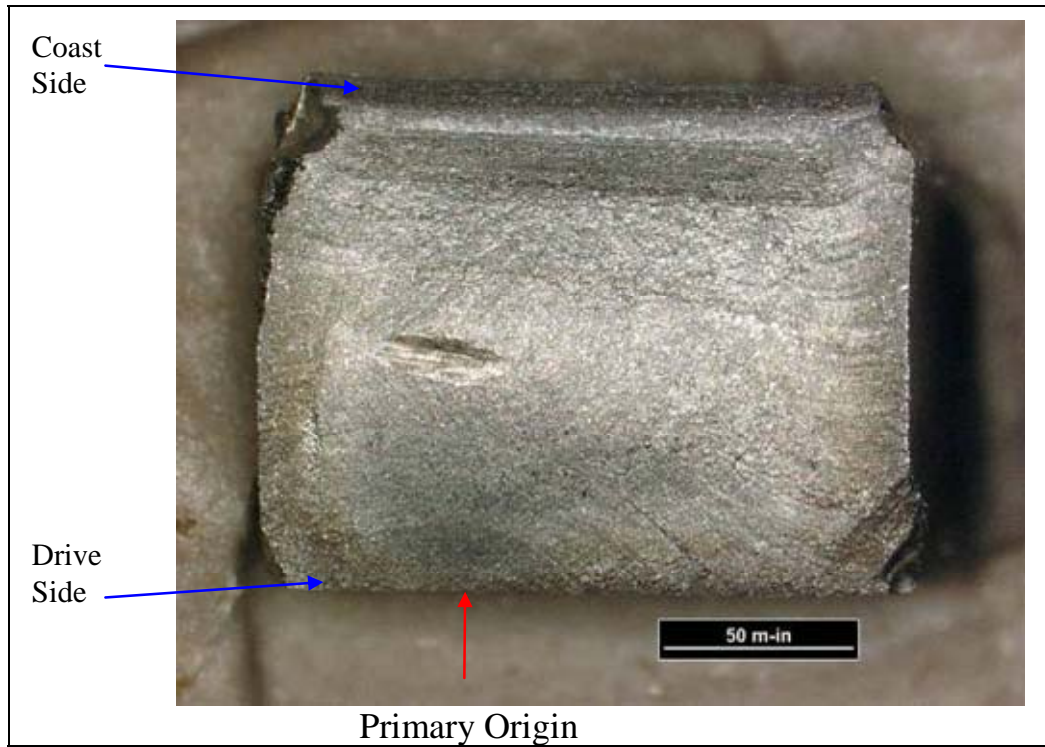
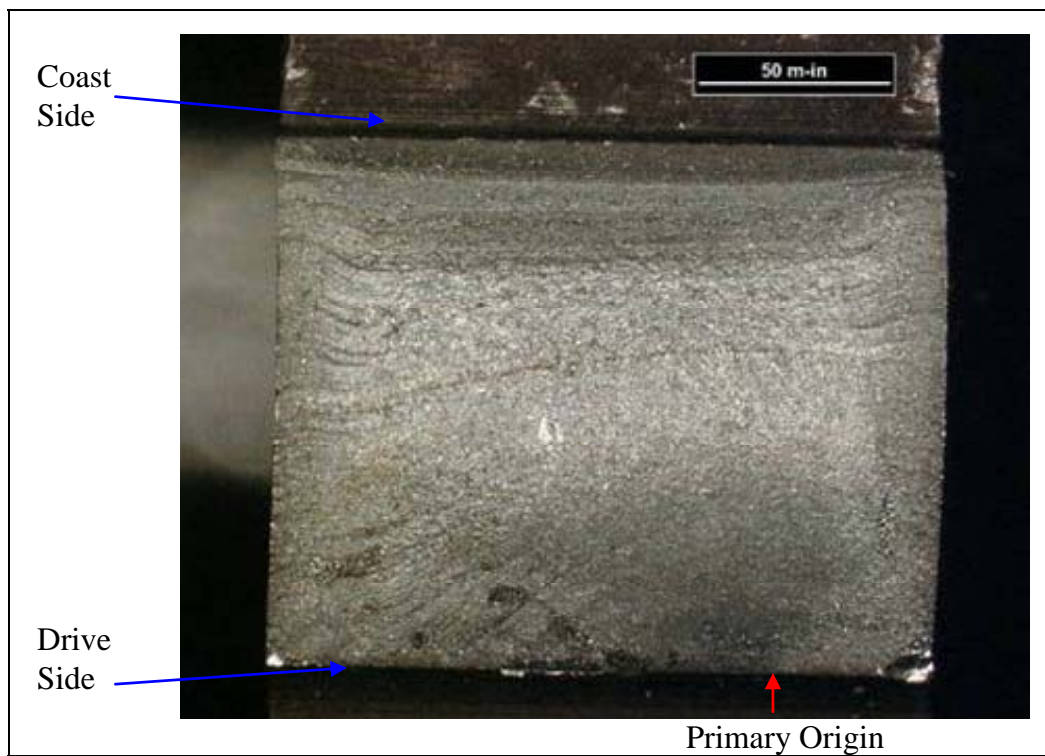
Fracture surfaces for tooth 1 are shown in figures 2–5. The primary origin for this tooth is shown in figure 4. Propagation was by fatigue with a secondary crack initiating on the coast side. A very small overload region was present, as depicted in figure 5.

Figure 2. Tooth 1, tooth fracture half.

Figure 3. Tooth 1, gear fracture half.

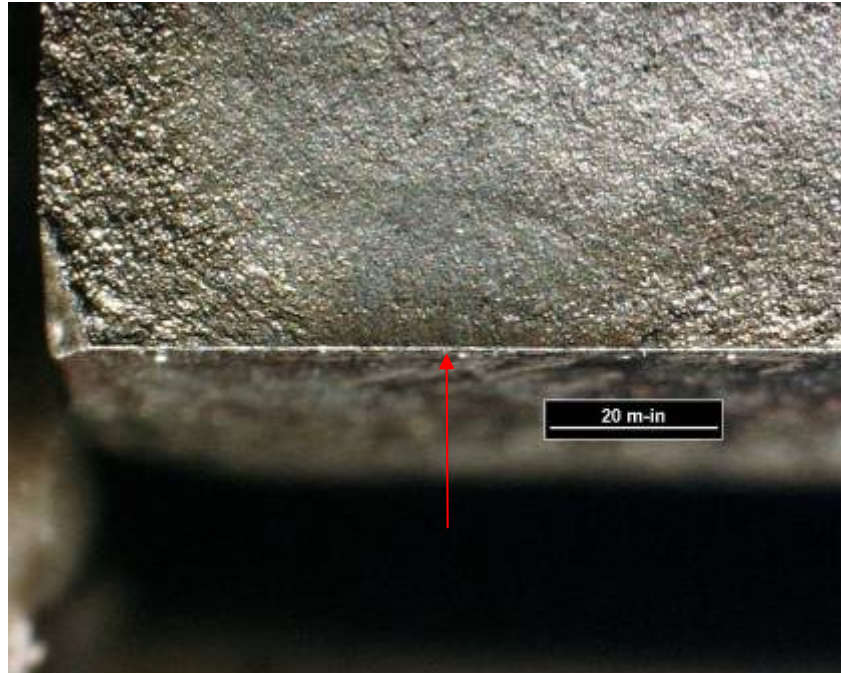
Figure 4. Primary origin, drive side of tooth 1, tooth fracture half.

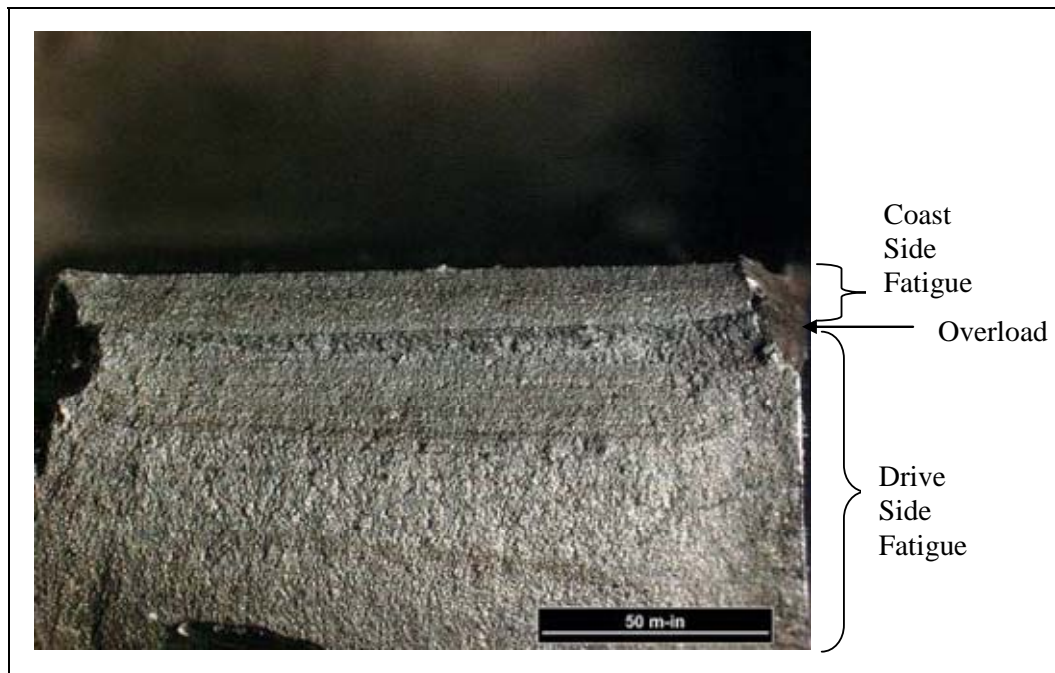
Figure 5. Coast side of tooth 1, tooth fracture half.

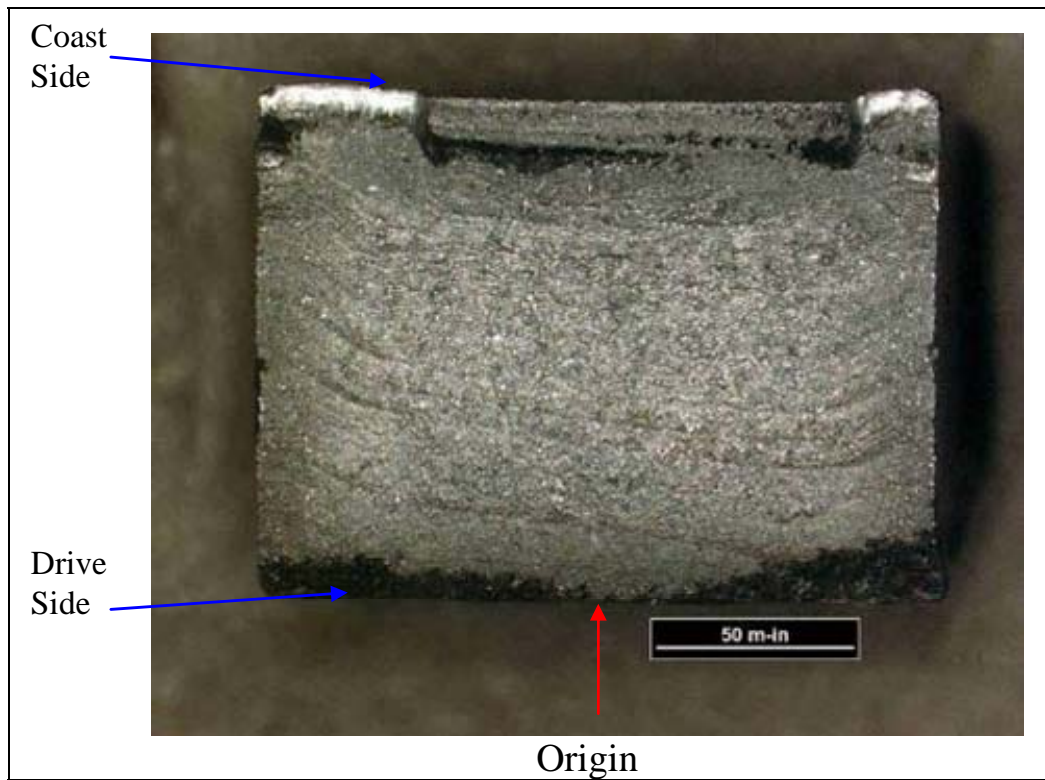
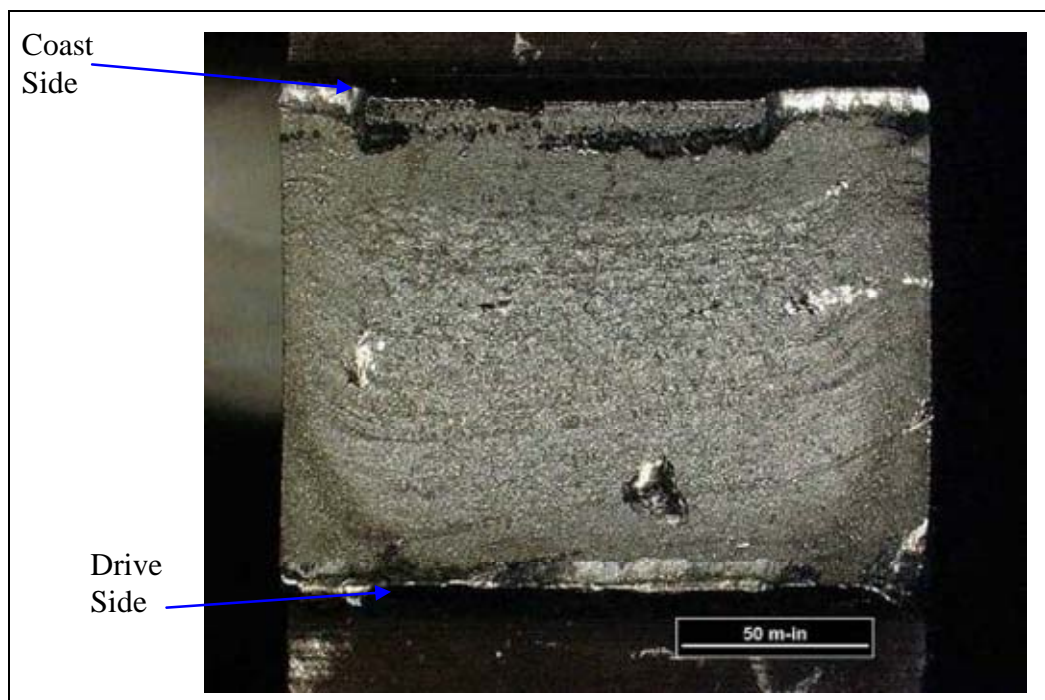
Figures 6 (tooth half) and 7 (gear half) show the fracture surfaces observed on tooth 2. Note the more pronounced beach marks relative to tooth 1.

Figure 6. Tooth 2, tooth fracture half.

Figure 7. Tooth 2, gear fracture half.

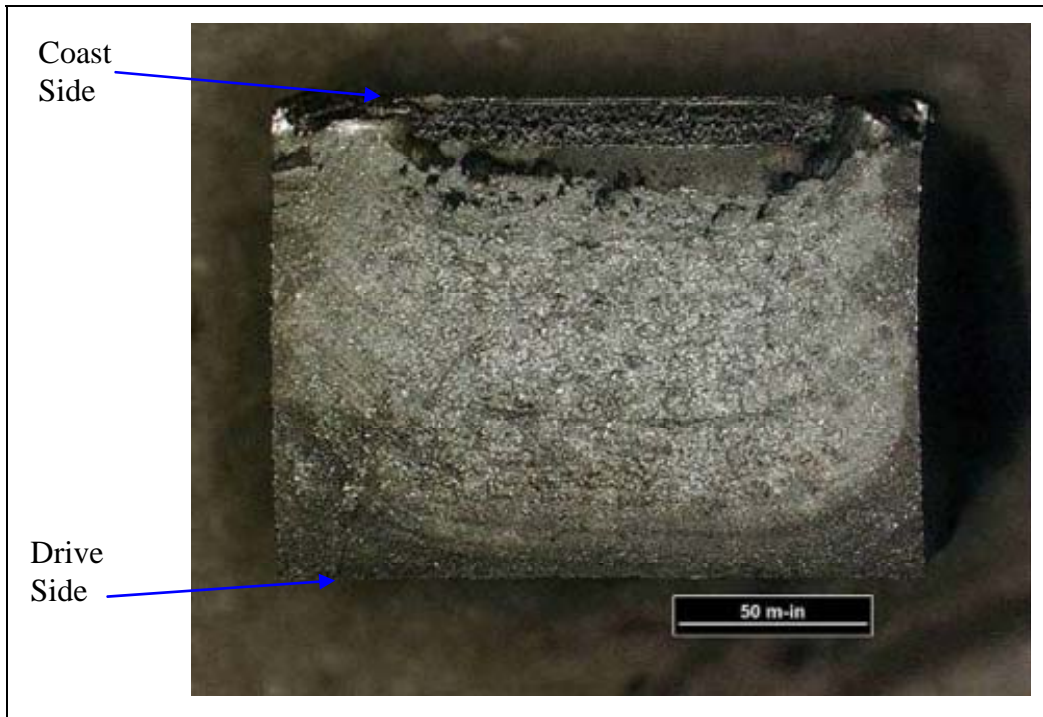
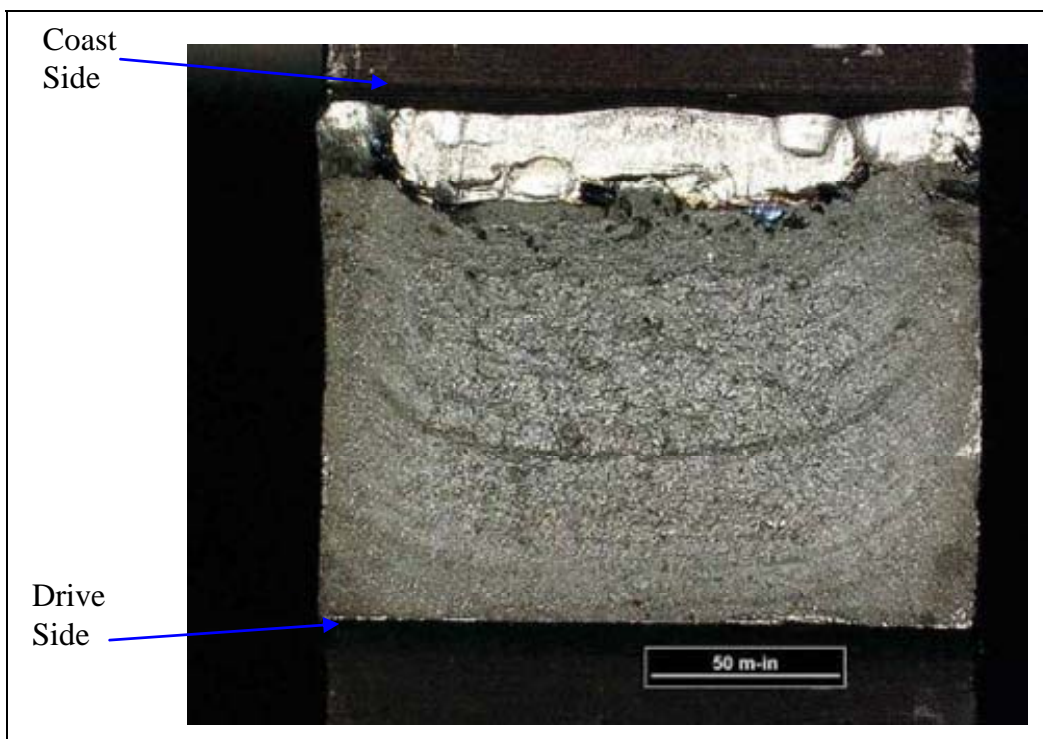
Figures 8 and 9, respectively, present the tooth and gear fracture halves of tooth 3. The overload region was significantly larger than on the preceding teeth.

Figure 8. Tooth 3, tooth fracture half.

Figure 9. Tooth 3, gear fracture half.

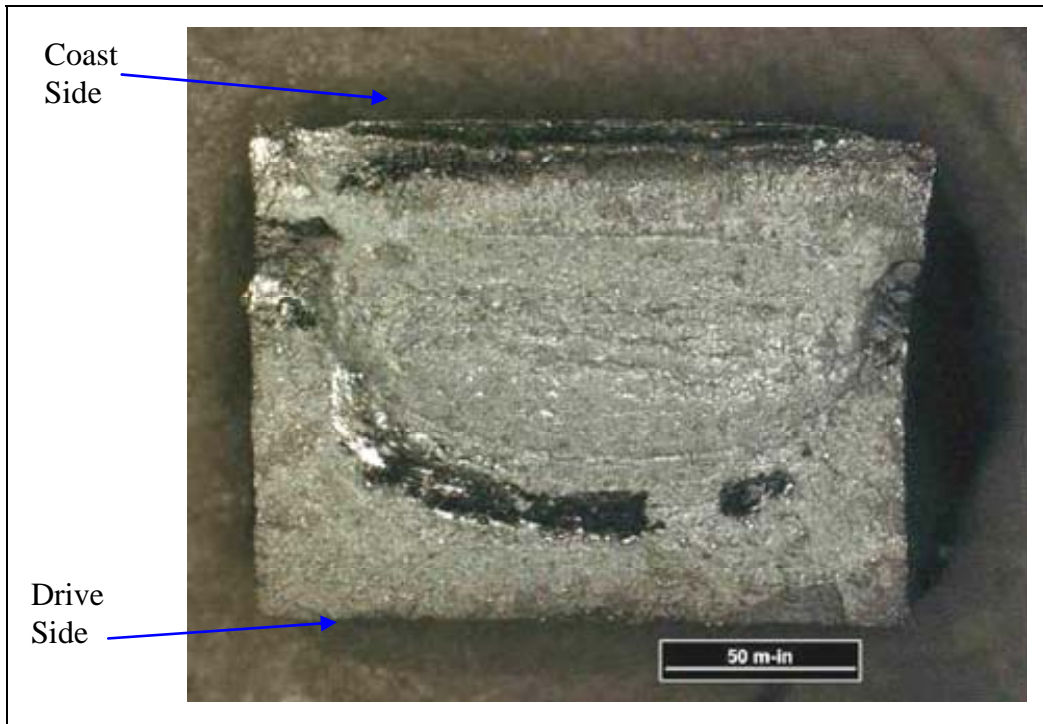
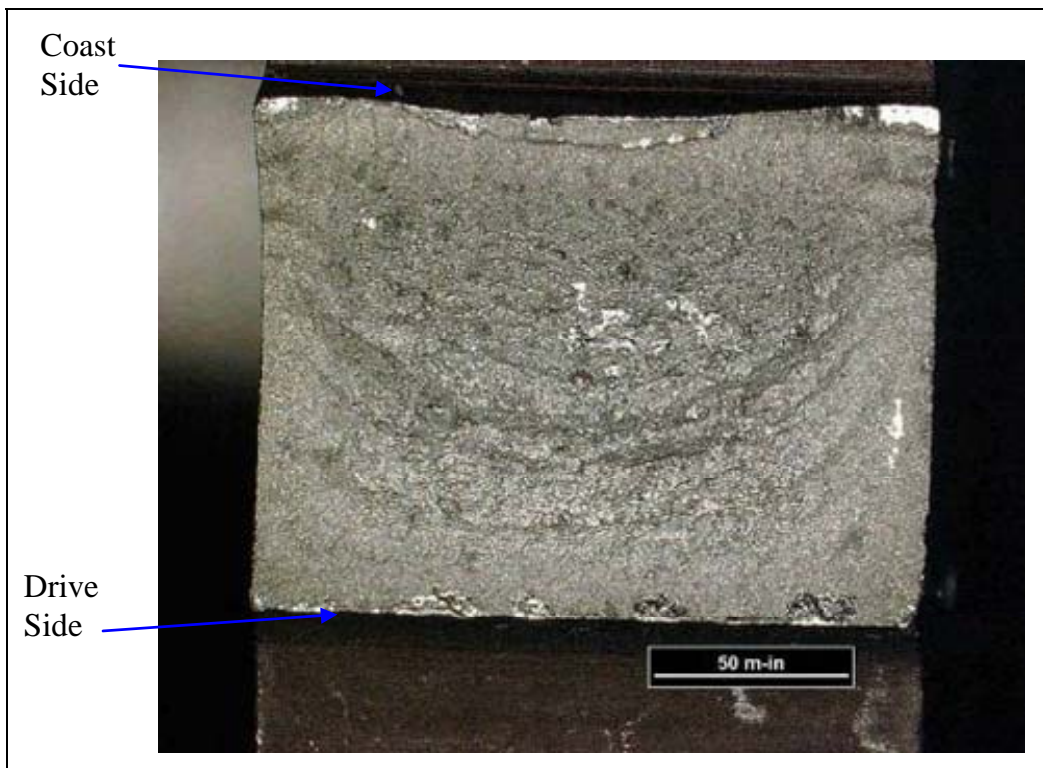
The fracture halves of tooth 4 are presented in figure 10 (tooth half) and figure 11 (gear half). The beachmarks exhibited a “U” or bathtub shape. A large mound can be seen in figure 10; the mating cavity can be seen in figure 11.

Figure 10. Tooth 4, tooth fracture half.

Figure 11. Tooth 4, gear fracture half.

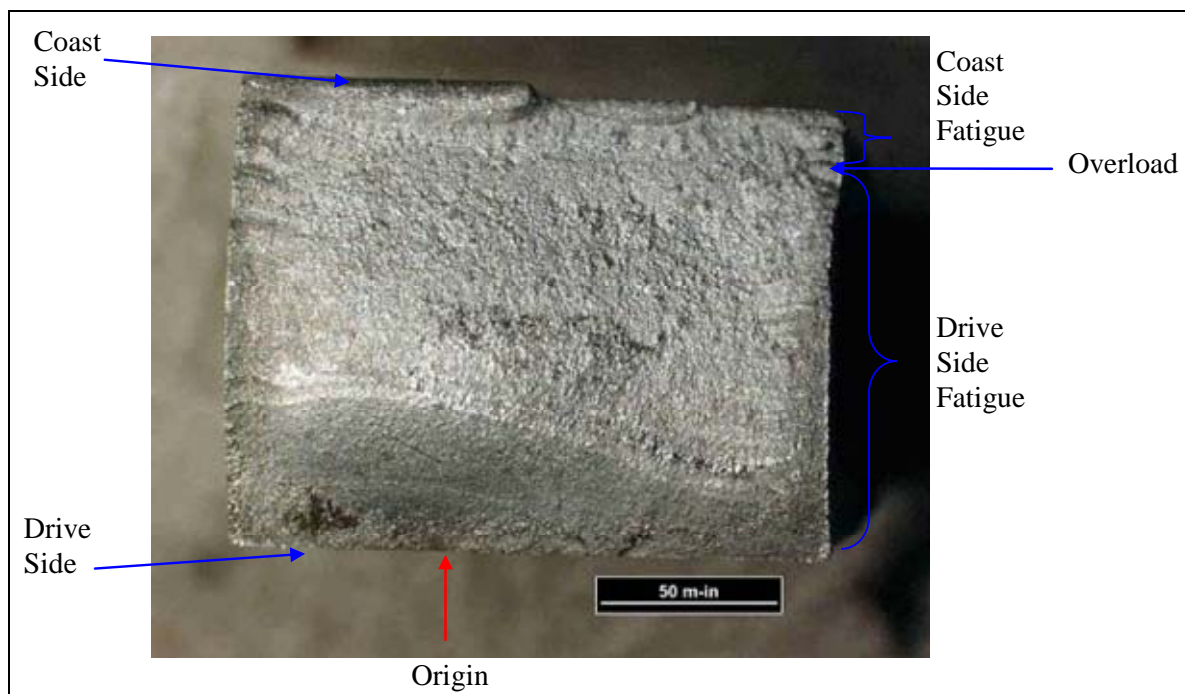
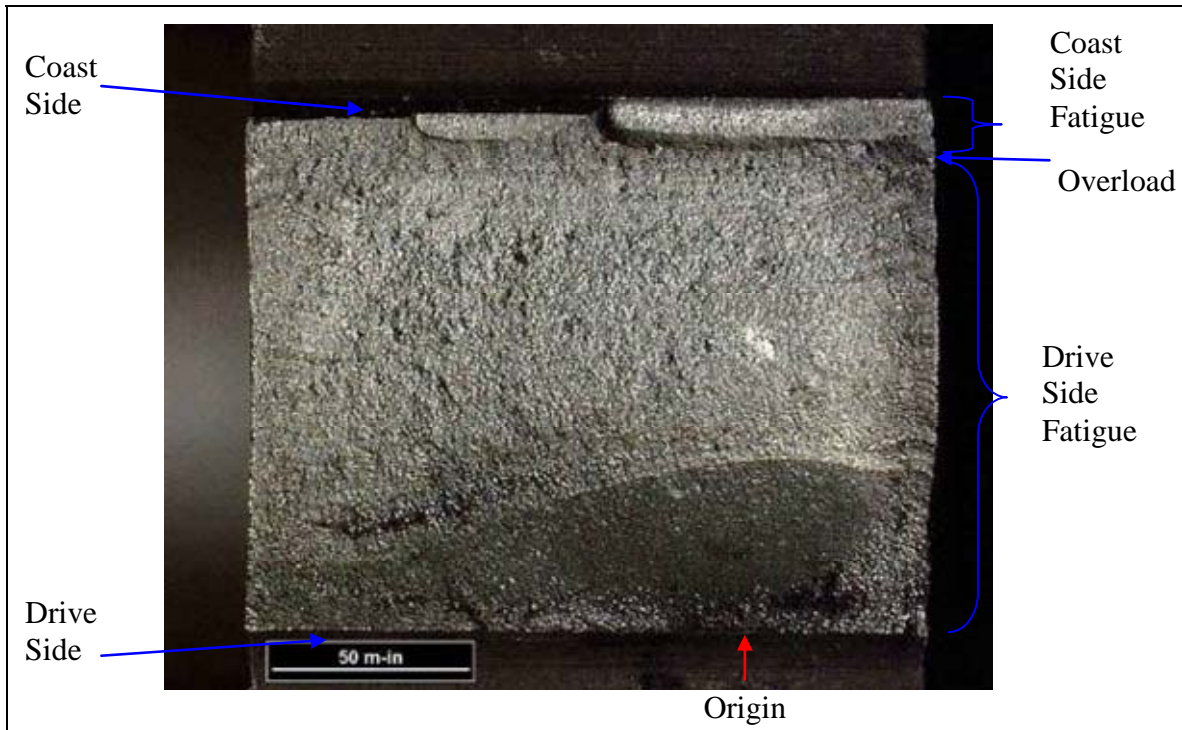
The primary failure for this group was tooth 28. The fracture halves are shown in figures 12 and 13. As in tooth 1, a secondary crack originated on the coast side. A small overload region was present.

Figure 12. Tooth 28, tooth fracture half.

Figure 13. Tooth 28, gear fracture half.

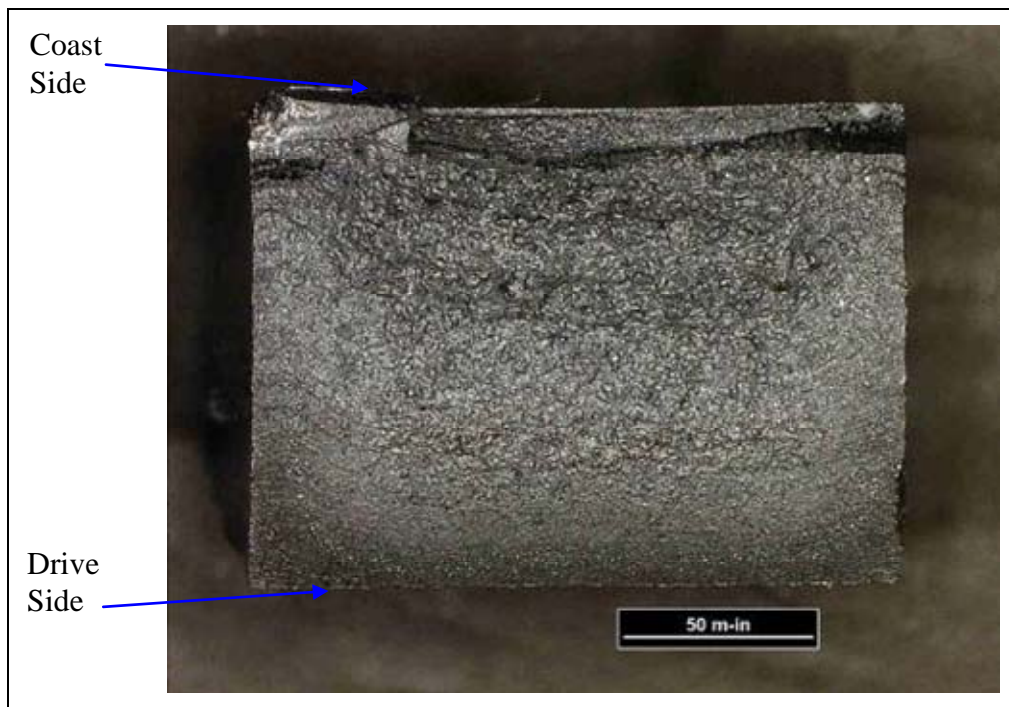
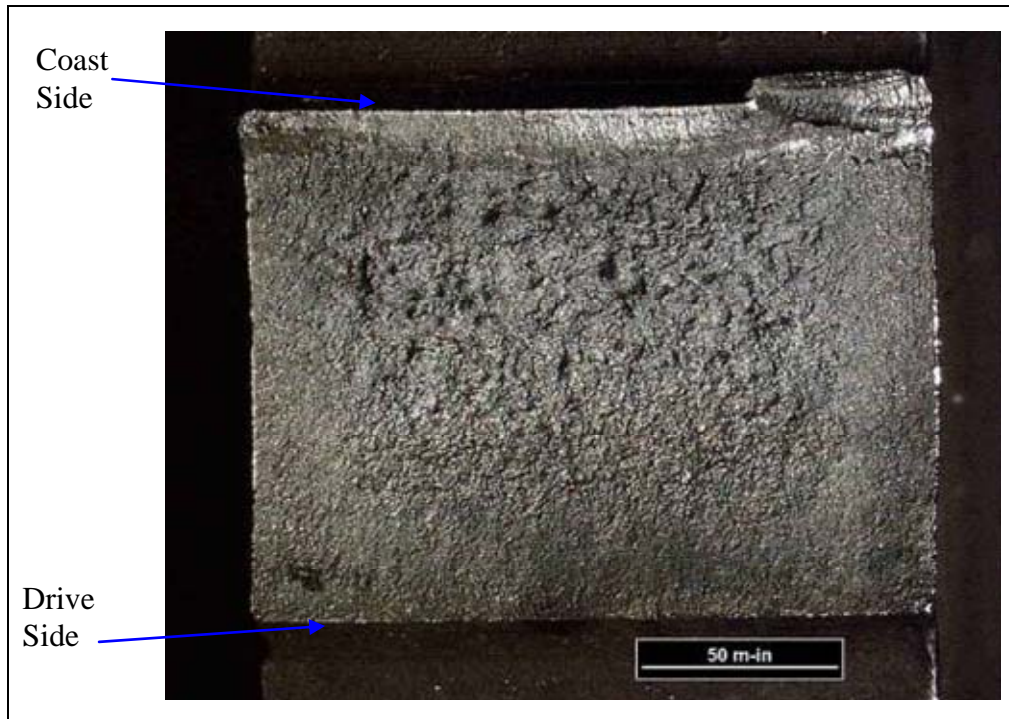
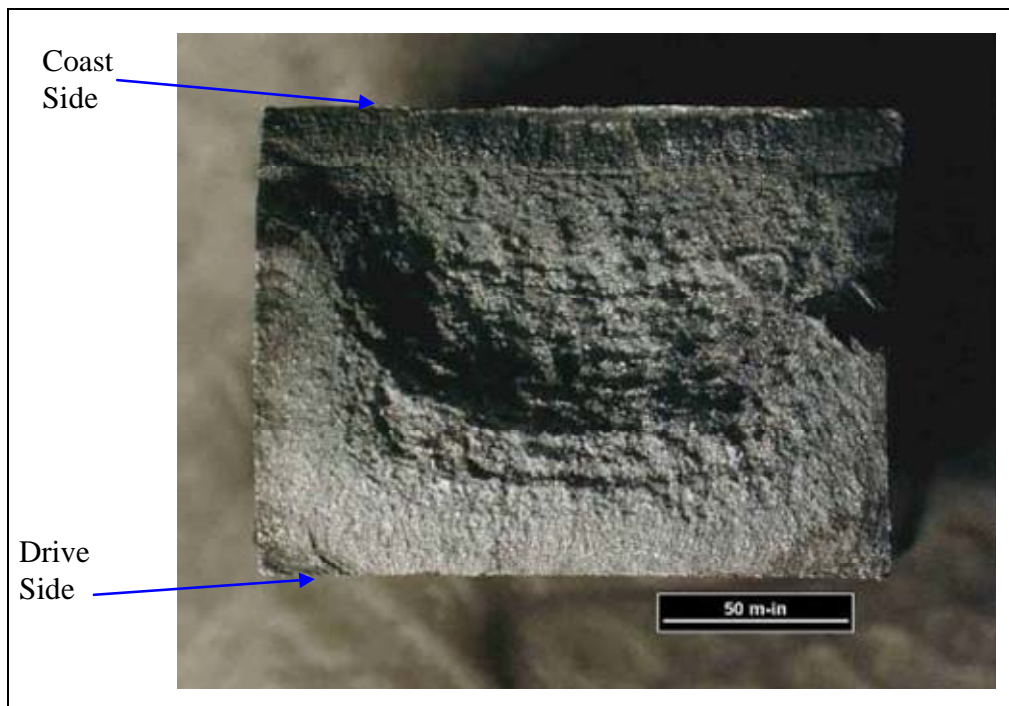
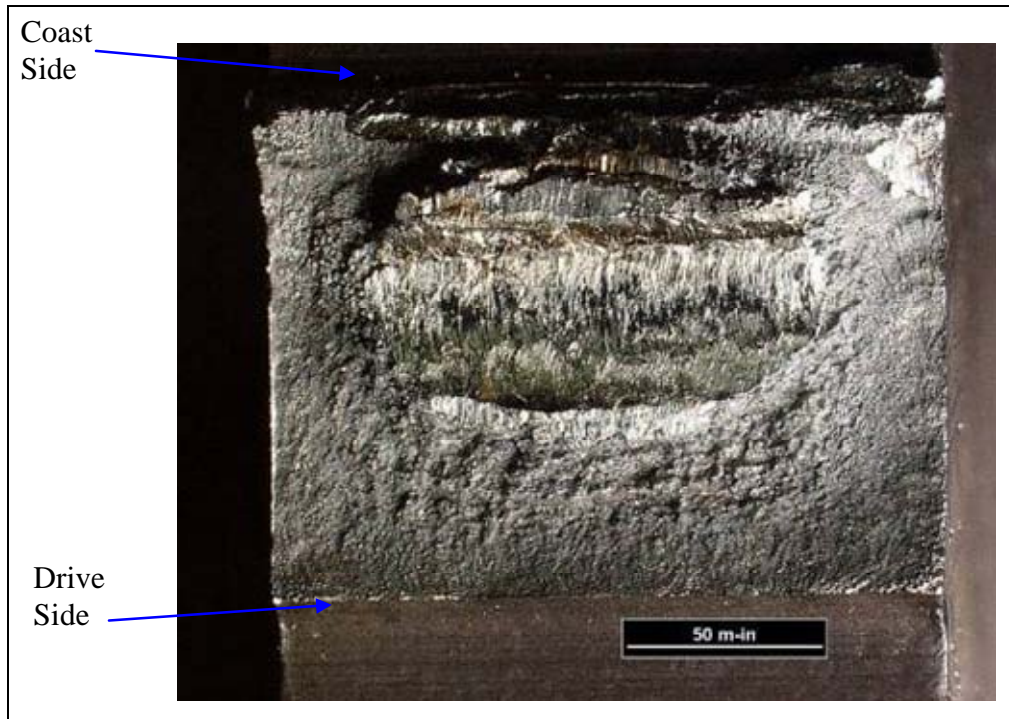
Tooth 29 fracture halves are shown in figures 14 and 15. Fracture halves for tooth 30 are shown in figures 16 and 17.

Figure 14. Tooth 29, tooth fracture half.

Figure 15. Tooth 29, gear fracture half.

Figure 16. Tooth 30, tooth fracture half.

Figure 17. Tooth 30, gear fracture half.

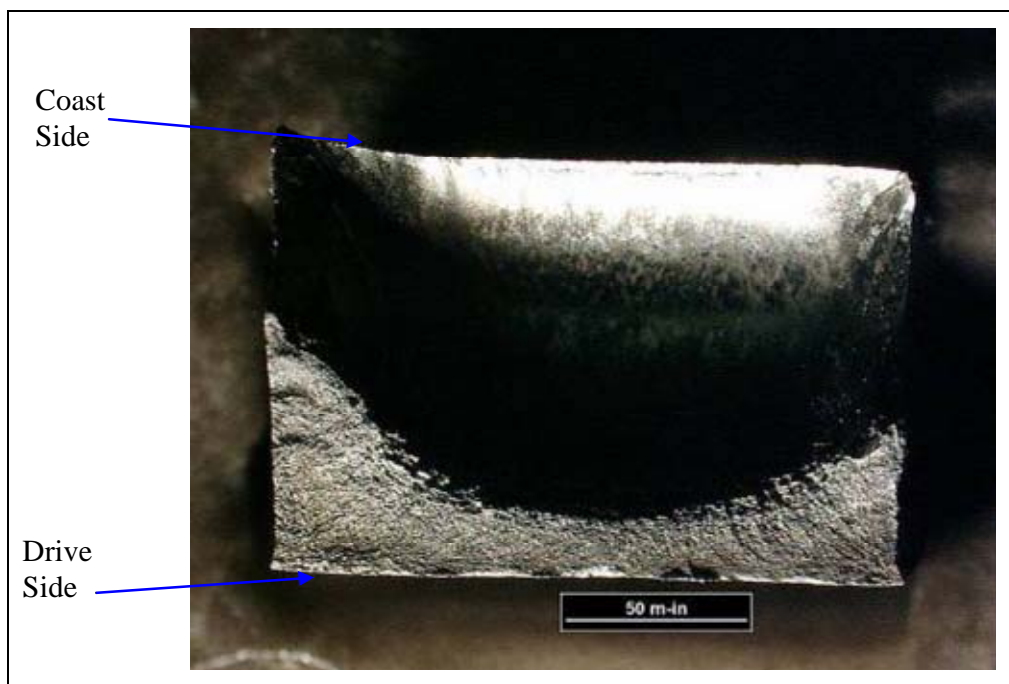
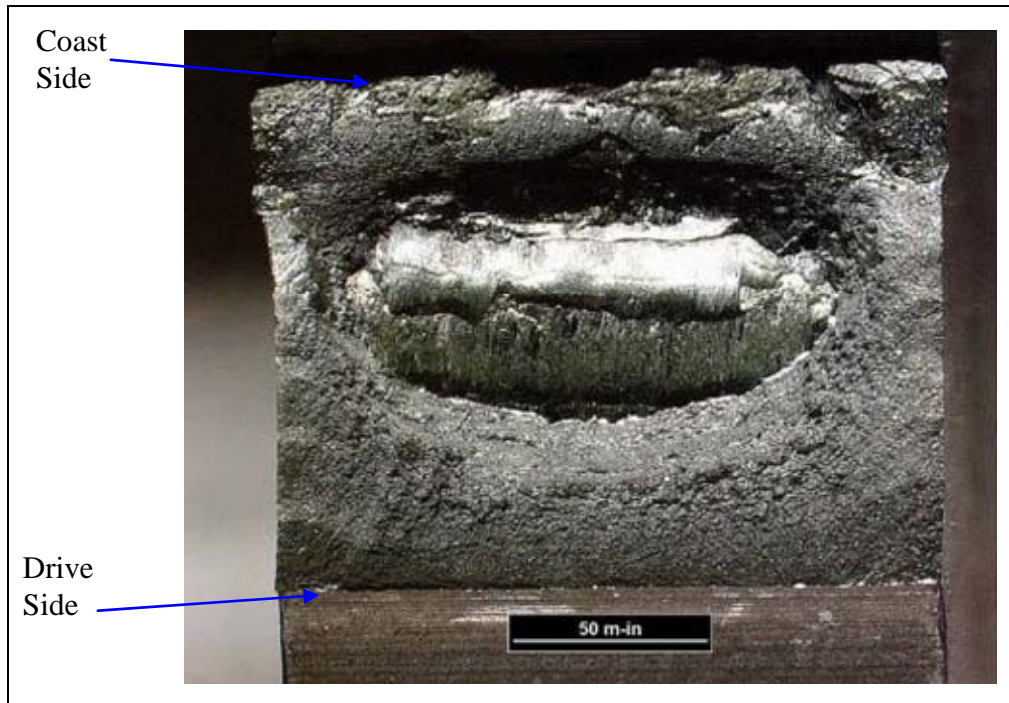
Figures 18 and 19 present the fracture halves for tooth 31. Wear was present at the drive side origin for this tooth (figures 26–28). Note that this was the last tooth in this sequence to fail by bending fatigue.

Figure 18. Tooth 31, tooth fracture half.

Figure 19. Tooth 31, gear fracture half.

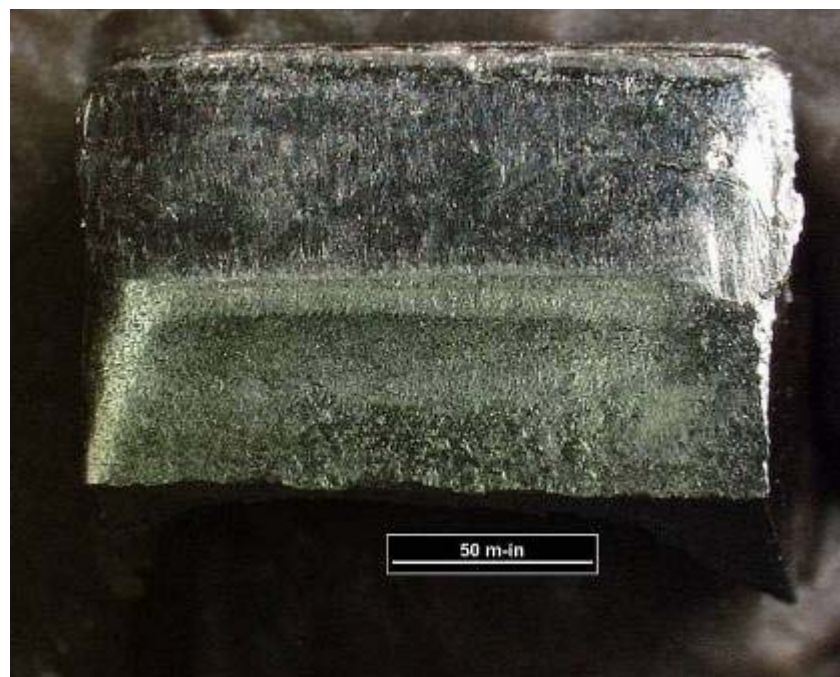
Figure 26. Drive side, tooth 31. (Note: worn adjacent to fracture surface.)

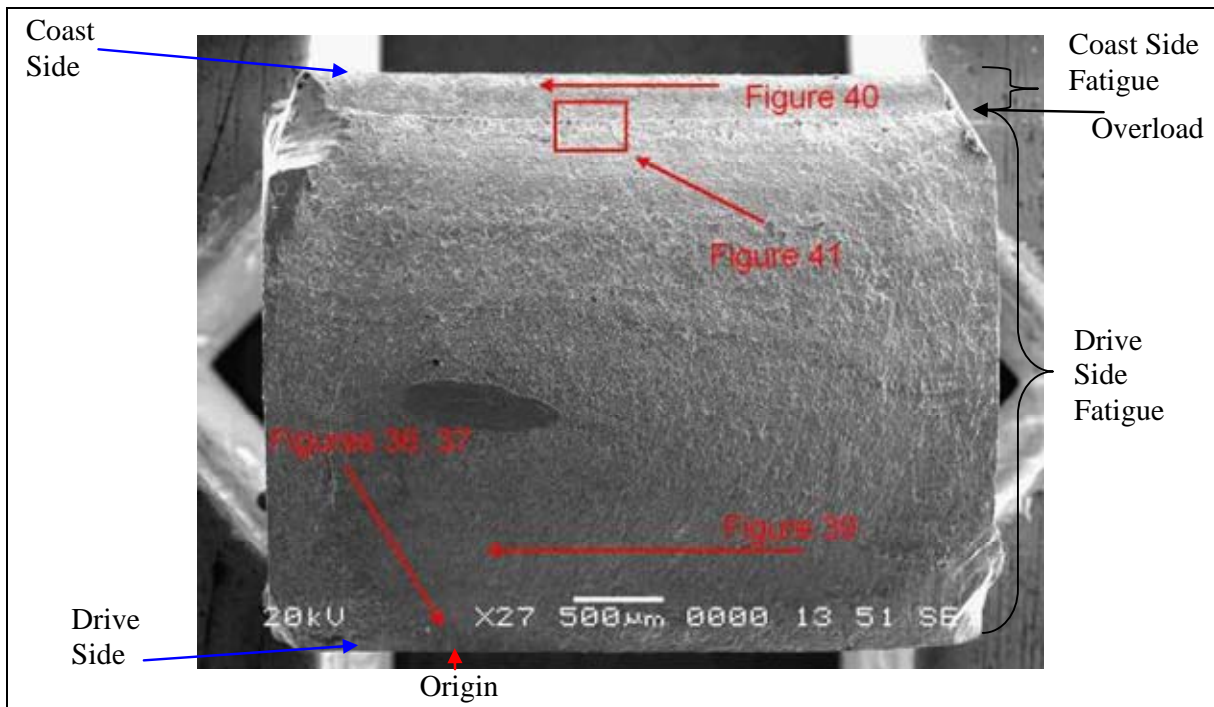
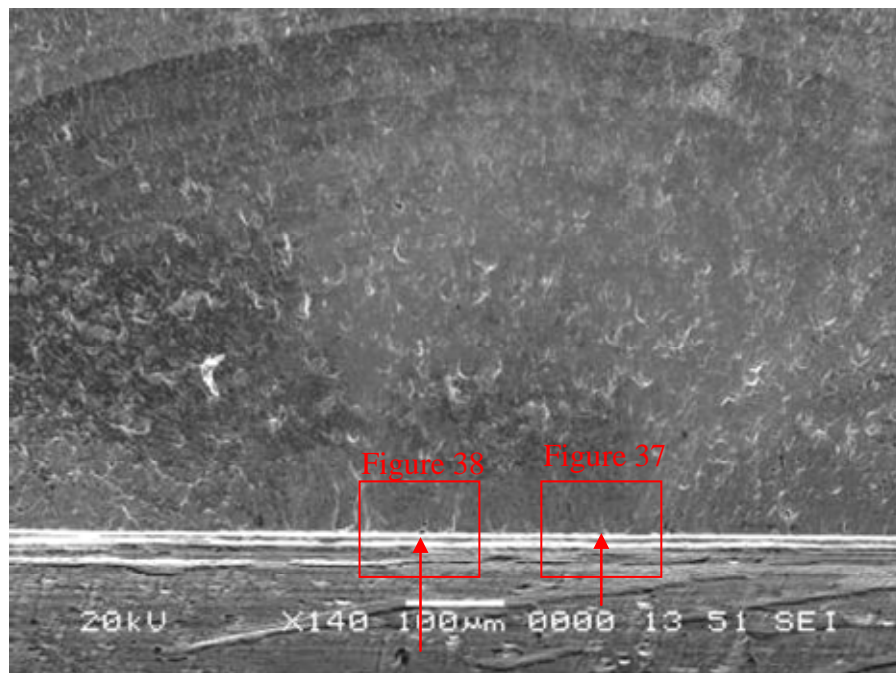
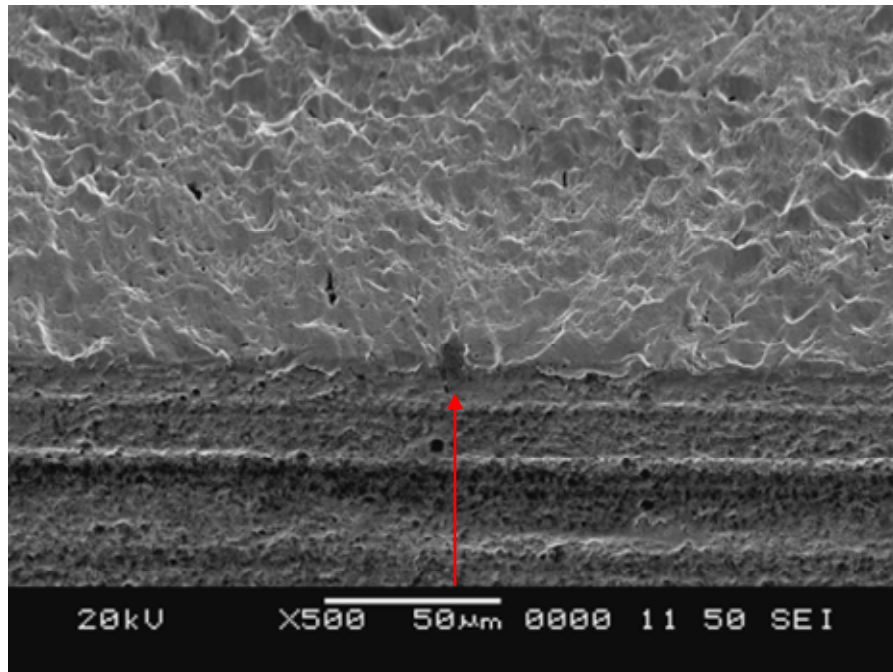
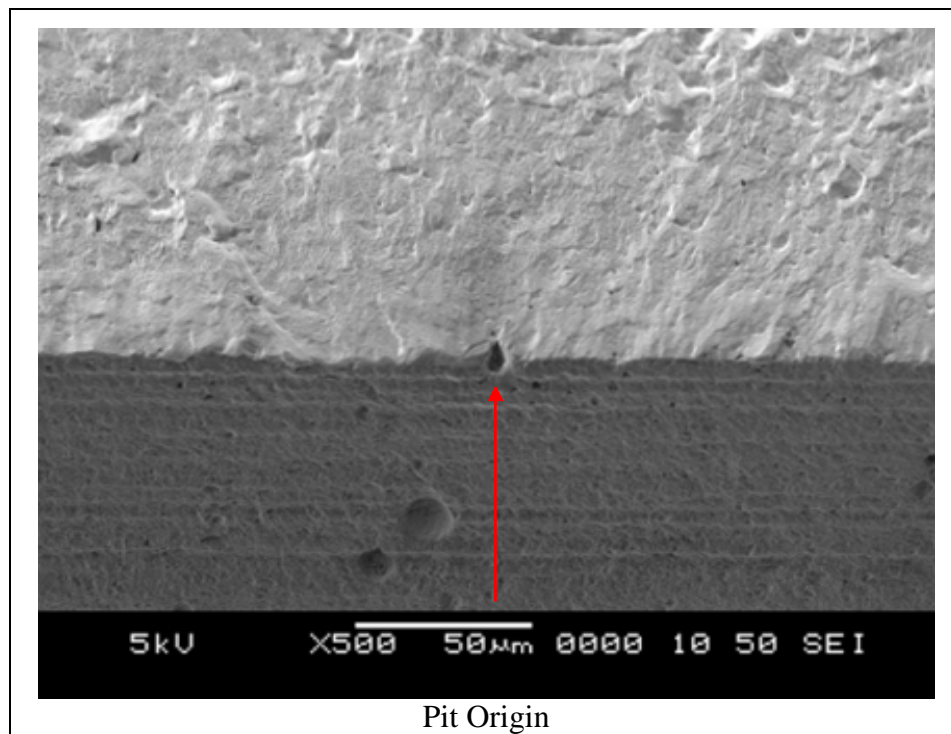
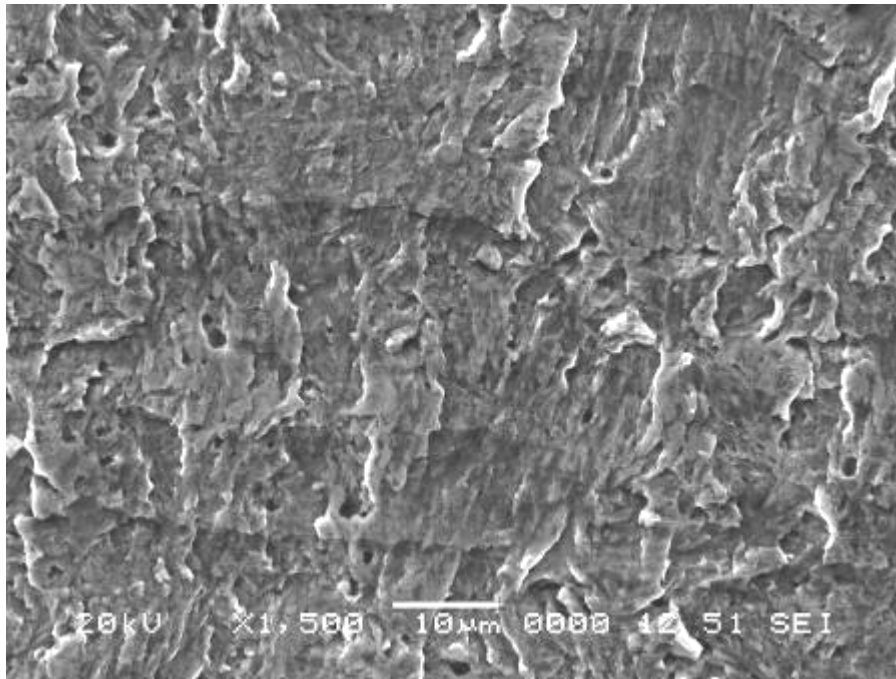
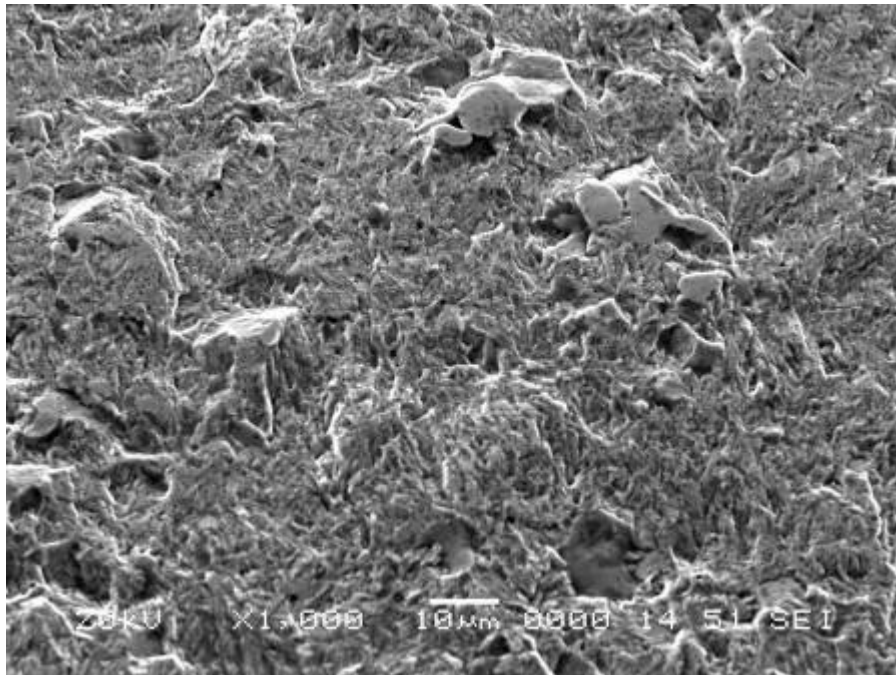
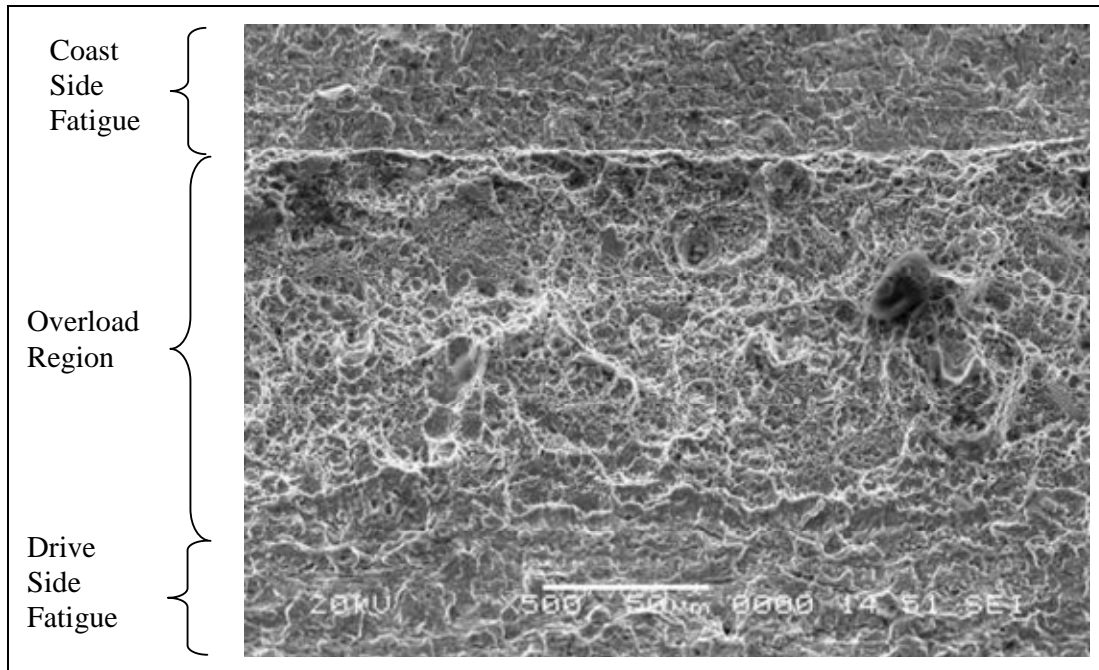
Figures 35–41 show SEM micrographs of tooth 1. Figures 36–38 present the origin for this primary failure. The pit origin can be clearly seen in figure 38. A separate crack originated from the coast side of the tooth and can be observed in figures 35 and 41. The two fractures connected through a small (100–150 μm) overload region as shown in figure 41.

Figure 35. Tooth 1.

Figure 36. Tooth 1 drive side origin.

Figure 37. Tooth 1 drive side pit origin site.

Figure 38. Tooth 1 primary origin, drive side gear fracture half.

Figure 39. Transgranular morphology, tooth 1 drive side.

Figure 40. Transgranular morphology, tooth 1 coast side.

Figure 41. Overload transition, tooth 1.

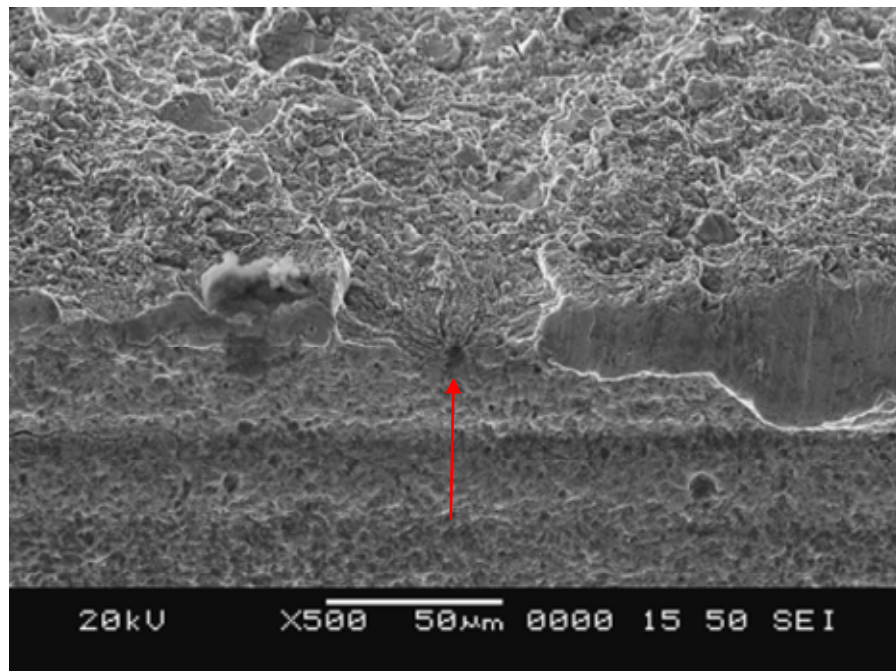
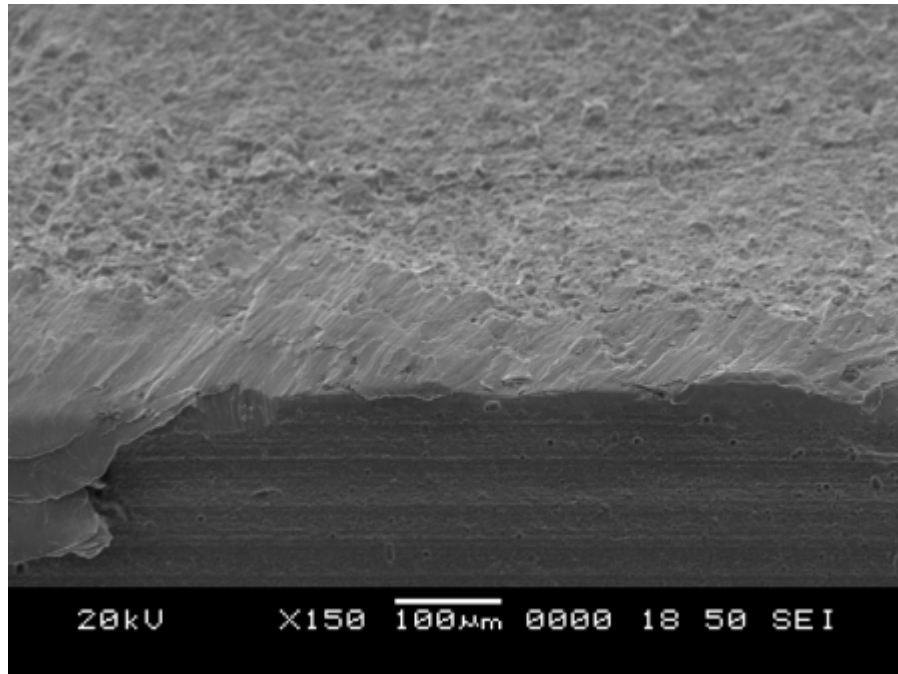
The pit origin for tooth 2 can be clearly seen in figure 42, which shows the tooth half of the fracture. Post fracture damage destroyed the gear half origin, depicted in figure 43.

Figure 42. Tooth 2 drive side primary pit origin, tooth half.

Figure 43. Drive side, tooth 2, gear half, origin location. (Note the damage.)

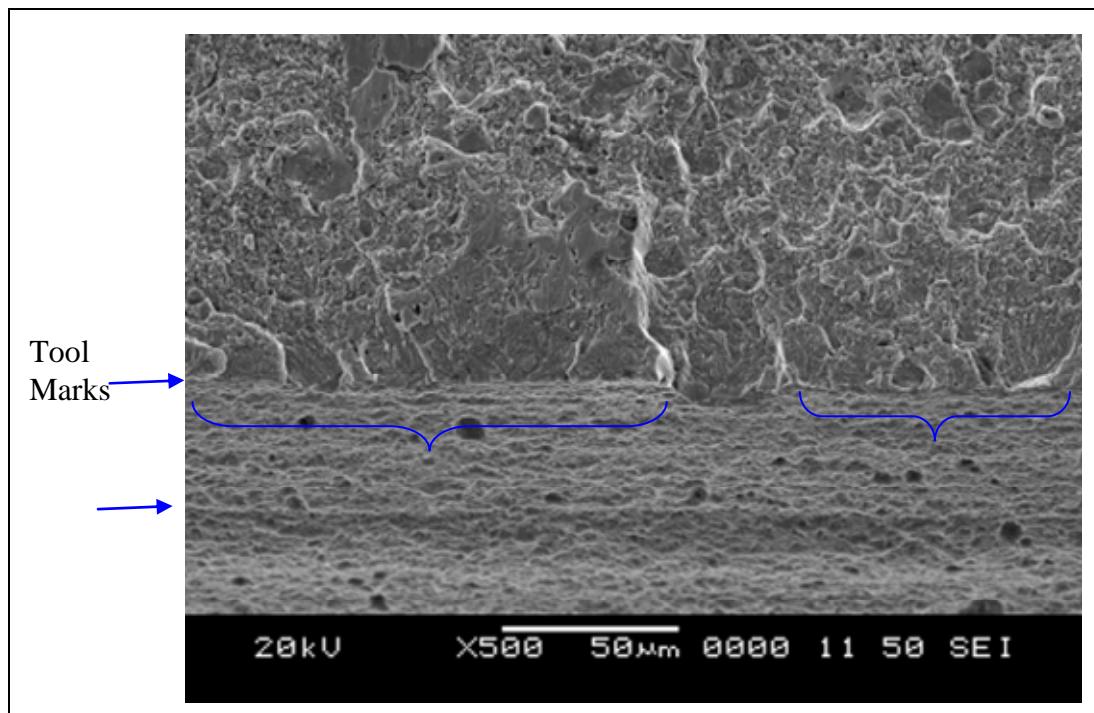
The origin for tooth 3 is shown in figure 44. Initiation appears to occur along a prominent tool mark.

Figure 44. Drive side, tooth 3, primary origin gear half.

- Identify and eliminate the source of the pitting.
 - Eliminate or reduce the magnitude of the tool marks present in the tooth root fillet.
-
